## **CSX Kanawha Trestle Inspection Report Charleston, West Virginia**

**Chris Knox, City Engineer**

**Michael Baker Jr., Inc.**

**August, 2011**

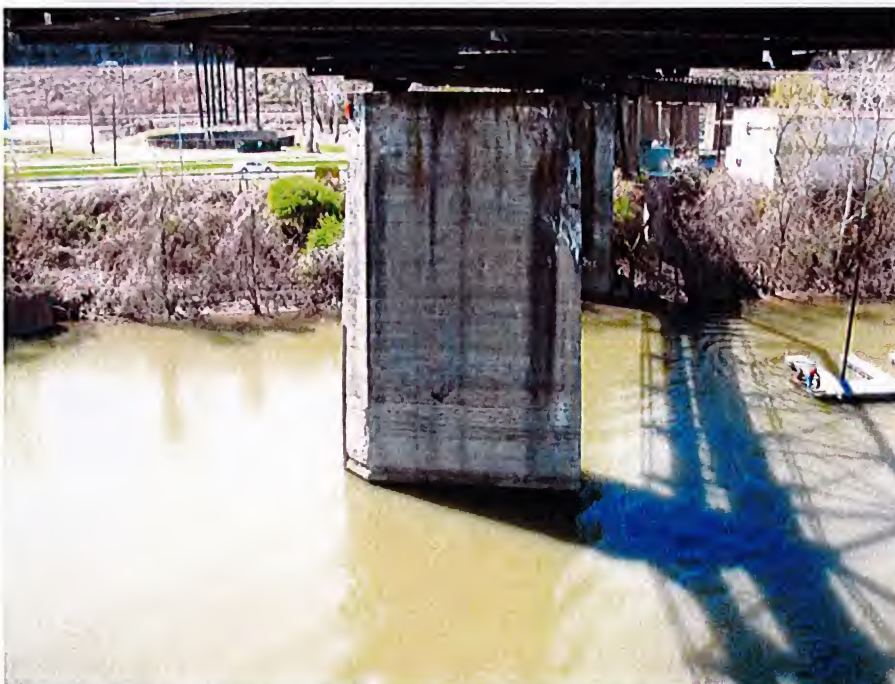
**Figure 2** *Typical River Pier*

1. The river piers are made of poor quality concrete by today's standards and are deteriorated significantly. The strength of the core samples revealed a concrete strength of approximately 1500 to 2500 psi in the upper portion of the pier shafts. Although chloride contamination does not seem to be a problem, the concrete strength and the condition of the piers in the upper 15 to 20 ft of the shaft beneath the truss bearings is in poor condition and exhibits concrete spalls up to 1 ft deep and extensive delamination, cracks and discoloration due to deteriorating concrete (See Photos 1-4 and Appendices). In addition to the deteriorated concrete, no reinforcing steel was found in the piers. Spalls and cores up to 12" deep at random locations did not encounter any rebar. As a result, significant strengthening will be required. Wrapping the piers with carbon fiber sheets is one possible method of strengthening the piers (Items 32 to 36 in the attached estimate).

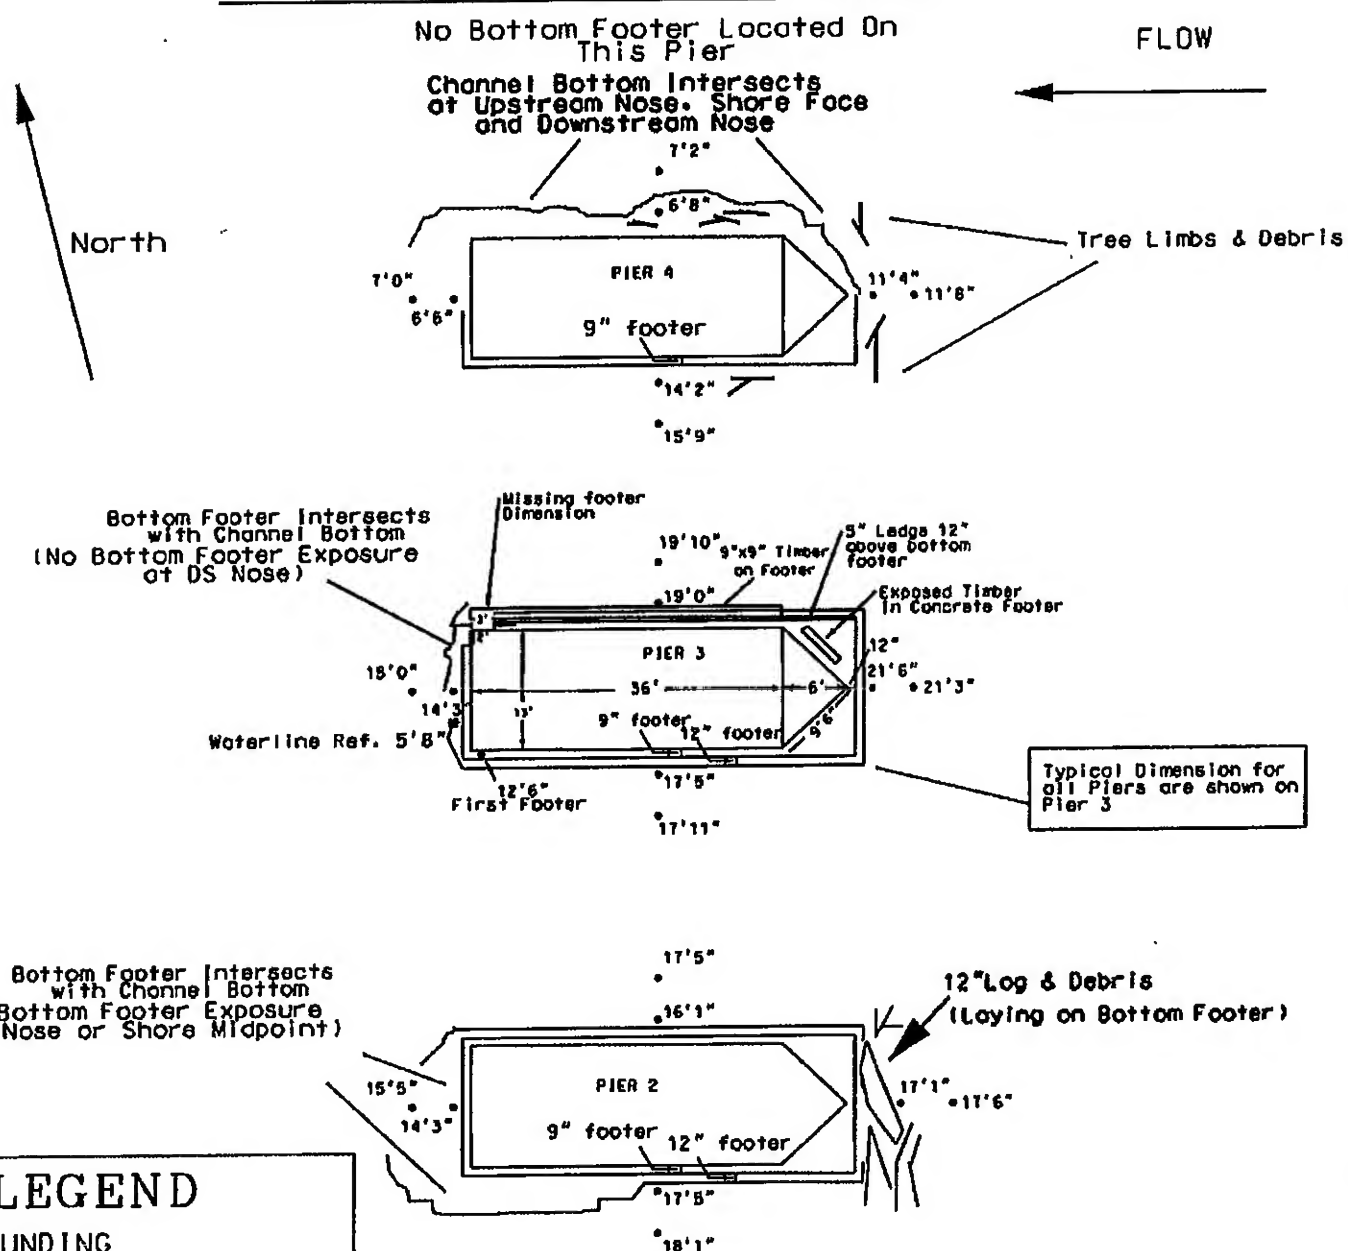
FIGURE 2

- 2.7.5 No fractures were noted on this pier, although a large void was noted about one-third of its length downstream, shore side corner. See Figure 2. The void in the concrete appeared about 6 inches from the channel bottom. It was 12 inches high, 4 feet long, and 2 feet deep.

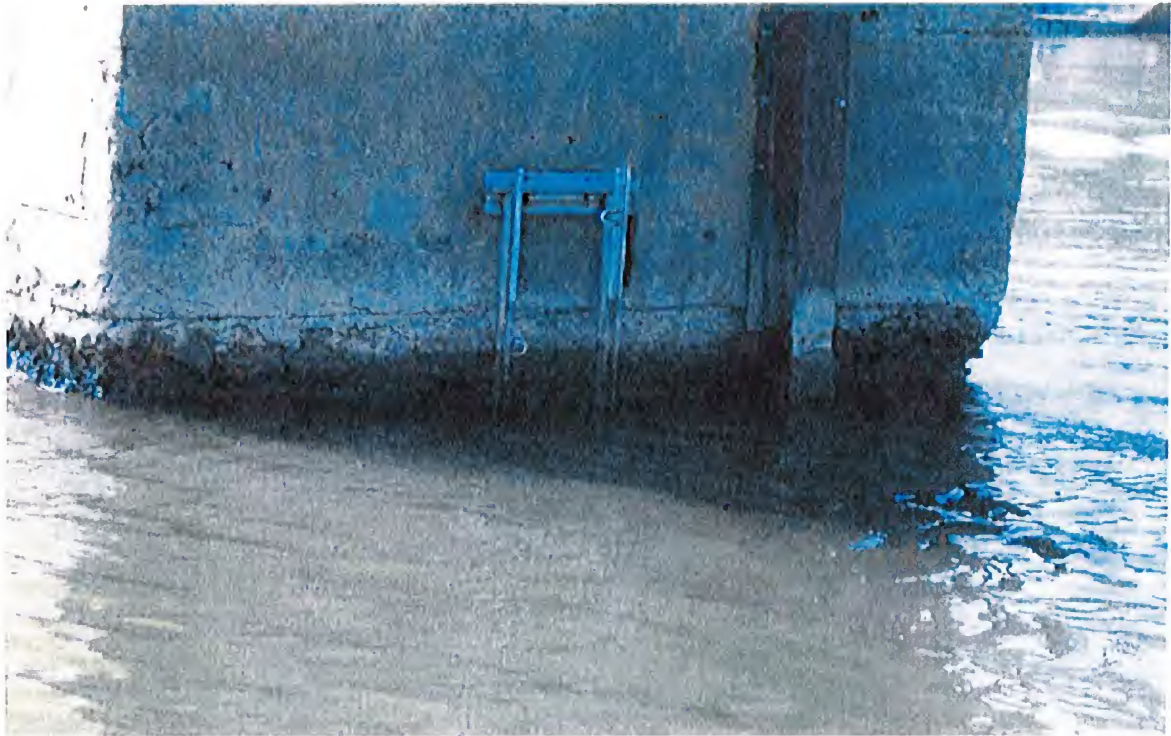
**Figure 3. Waterline reference located on the downstream nose of Pier 3**
